Implementing Solutions: The Martins Pond Shoreline Restoration and Sedimentation Reduction Project

- Martins Pond is located in North Reading, 20 miles North of Boston
- The shoreline is densely developed, stretches are unnatural and eroded
- Town of North Reading awarded a grant restore the shoreline

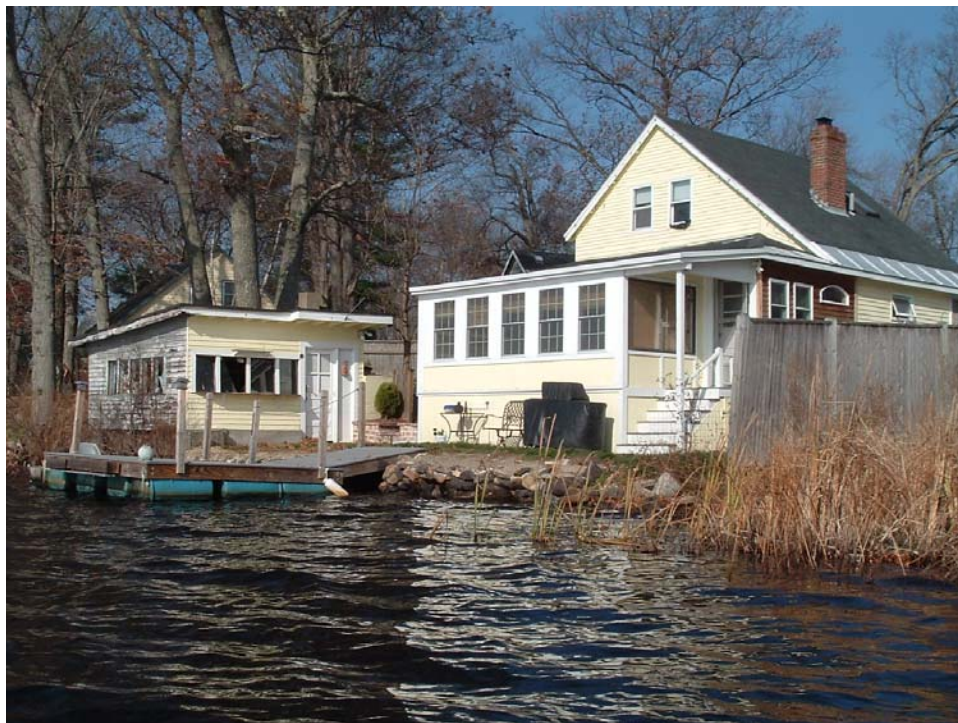
Erosion Value 5
Vegetation Value 5

The barren shoreline is eroding under the yellow boathouse and all along the wall.
In contrast, the vegetated neighbor has protection from ice, wind, and waves, and shows no signs of erosion.

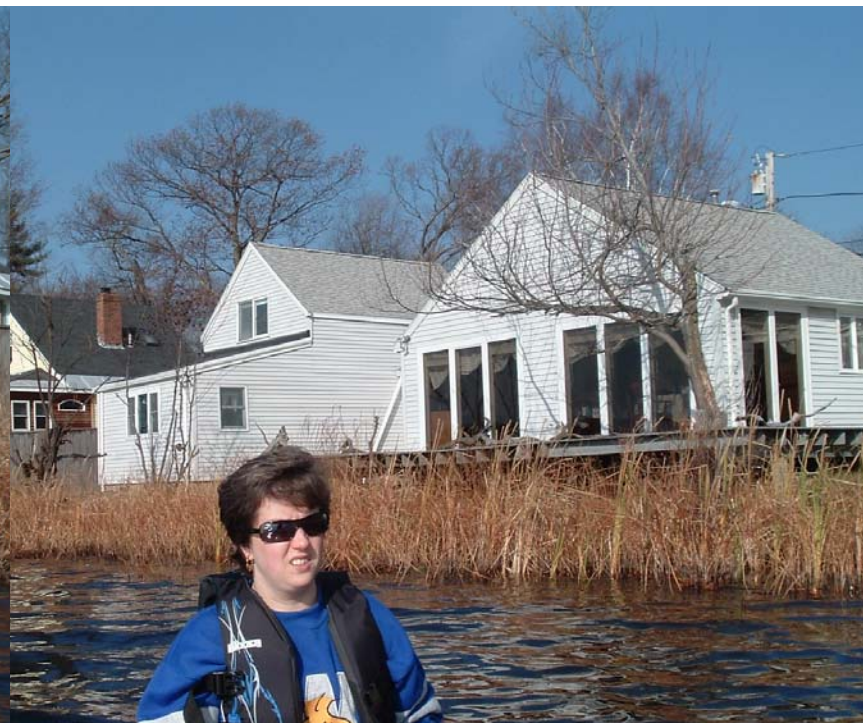
Erosion Value 0
Vegetation Value 1

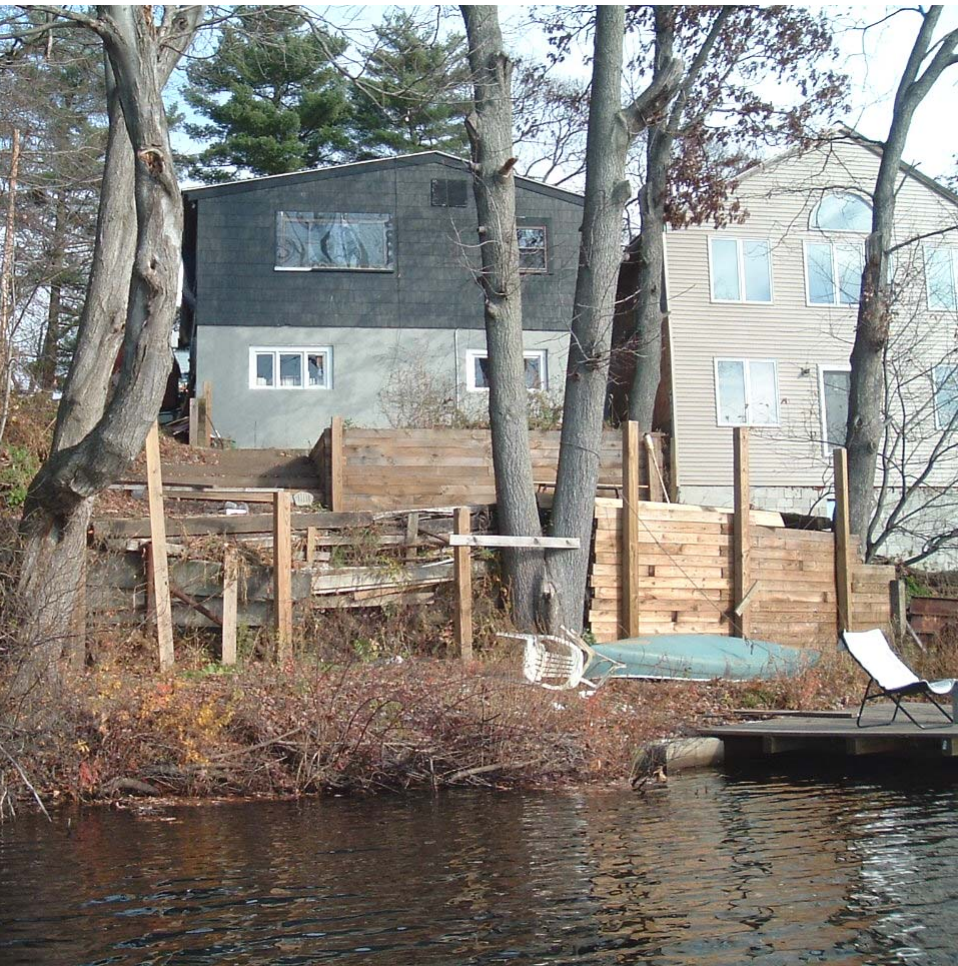
Owner at left has been cited for clearing shoreline, but attempts to hold back the soil have not included vegetation, and continue to fail. Parcel at right has tree canopy and untouched hill, very little erosion.

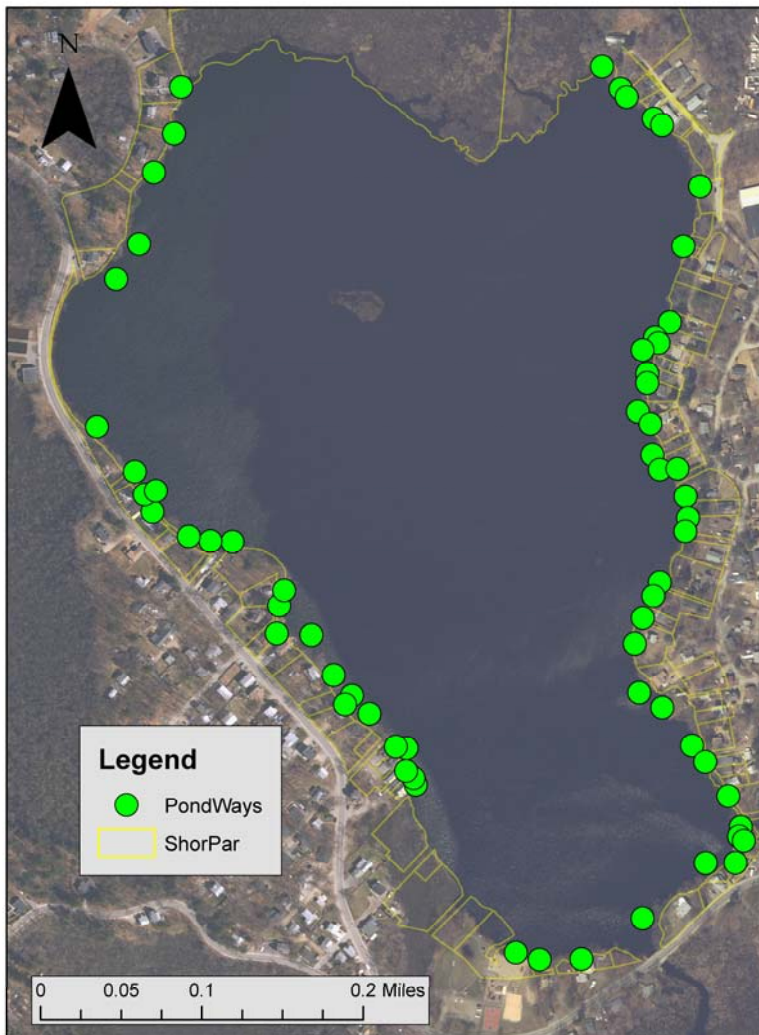
BEFORE

Step Three: Download waypoints and build attribute table. Waypoints had to be edited to place them within parcel polygons so a one to one cardinality could be achieved for the inside join with shore parcels layer as destination.

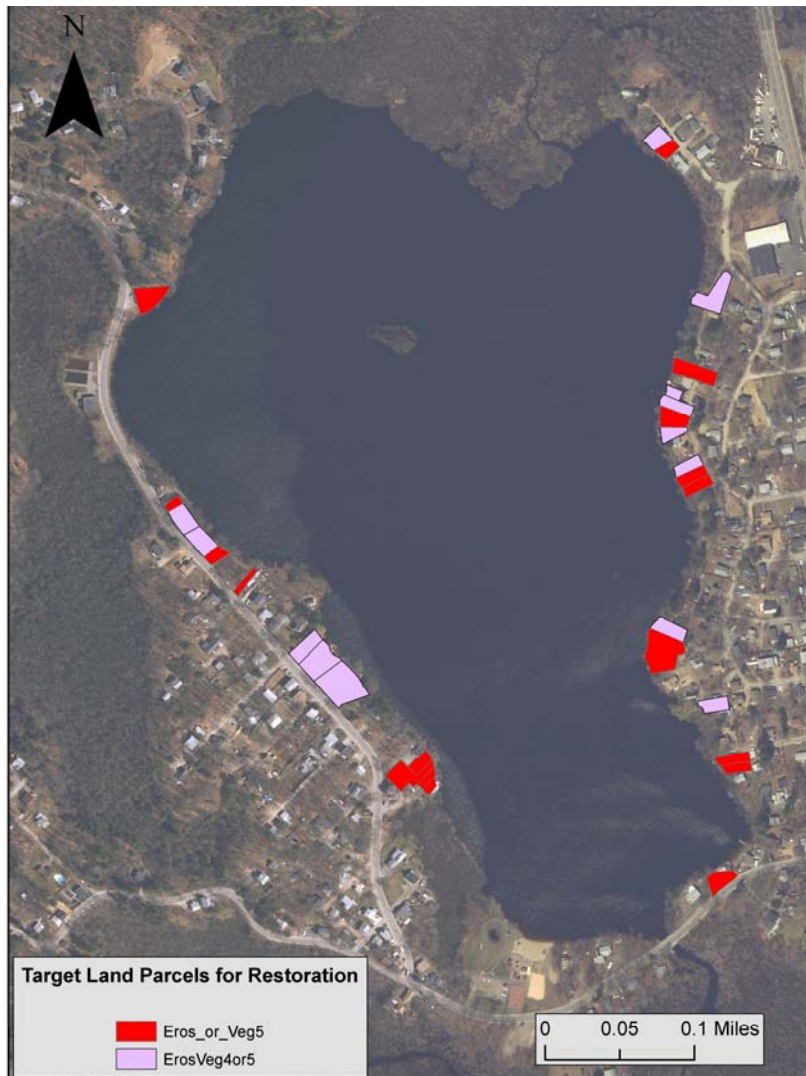
Parcels with Erosion **or** Vegetation values of 5 are shown in red . This group of 17 parcels is our “A” list of target shoreline residents to solicit for inclusion in remediation efforts.

Parcels with Erosion **or** Vegetation Values of 4 are shown in pink. This group of 13 are the “B” list of target properties.
